## Community High-Water Storm Surge Mapping Network

Dr. Tim Webster, Research Scientist  
Applied Geomatics Research Group – COGS, NSCC  
Partner Organization Emergency Management Office

March, 2011

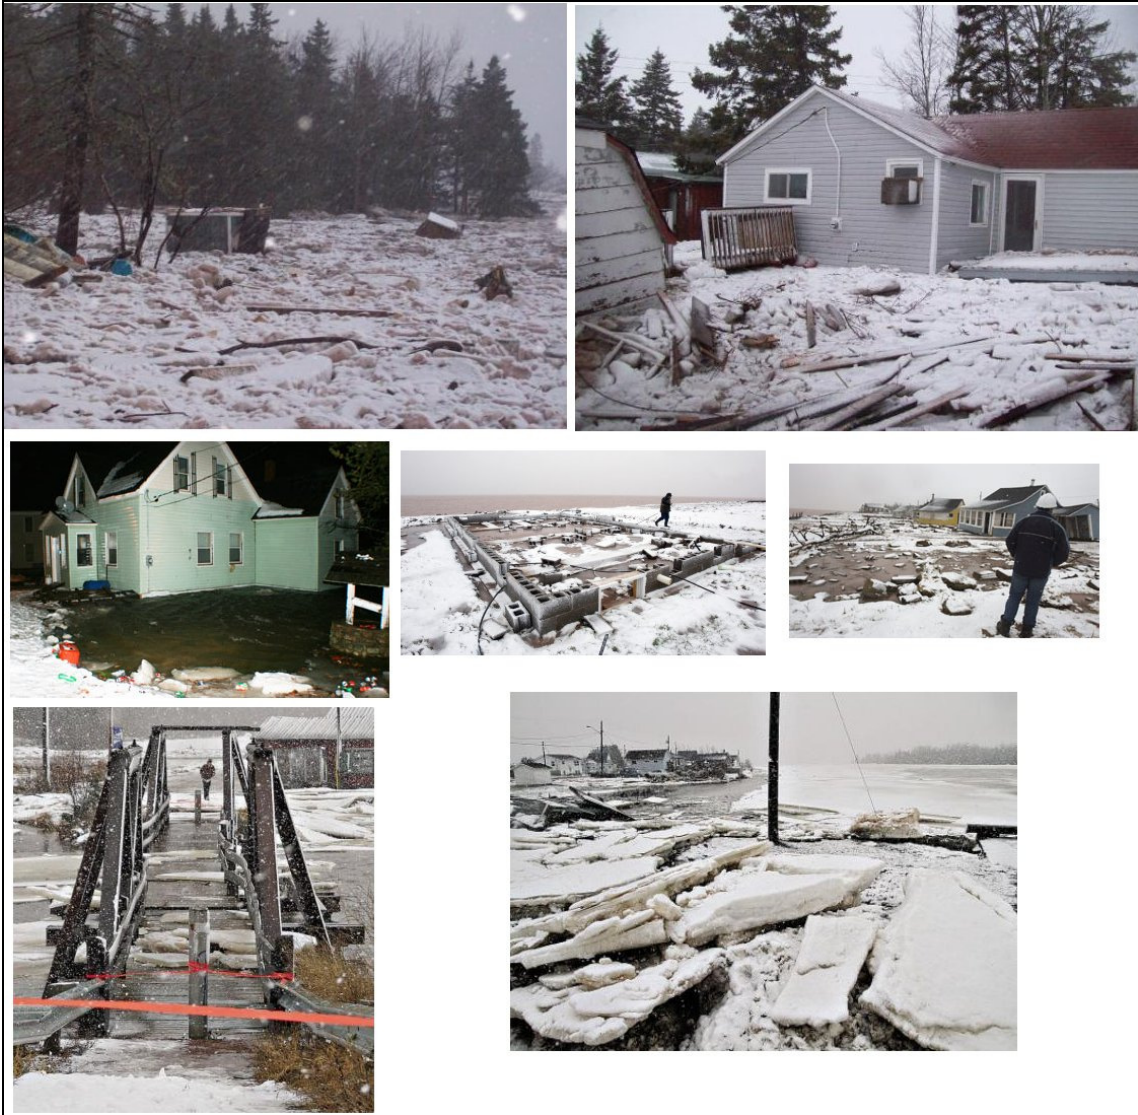
**Figure 6 Port Elgin storm damage. Top photos courtesy of Kristy Boudreau. The next row of photos courtesy of Sackville Tribune, Globe and Mail, and the CBC.**

On Jan. 2-3, 2010 a low pressure storm system affected the coast of the Northumberland Strait. Port Elgin, NB was severely affected and sustained coastal flooding as a result of the storm surge (Fig. 6).

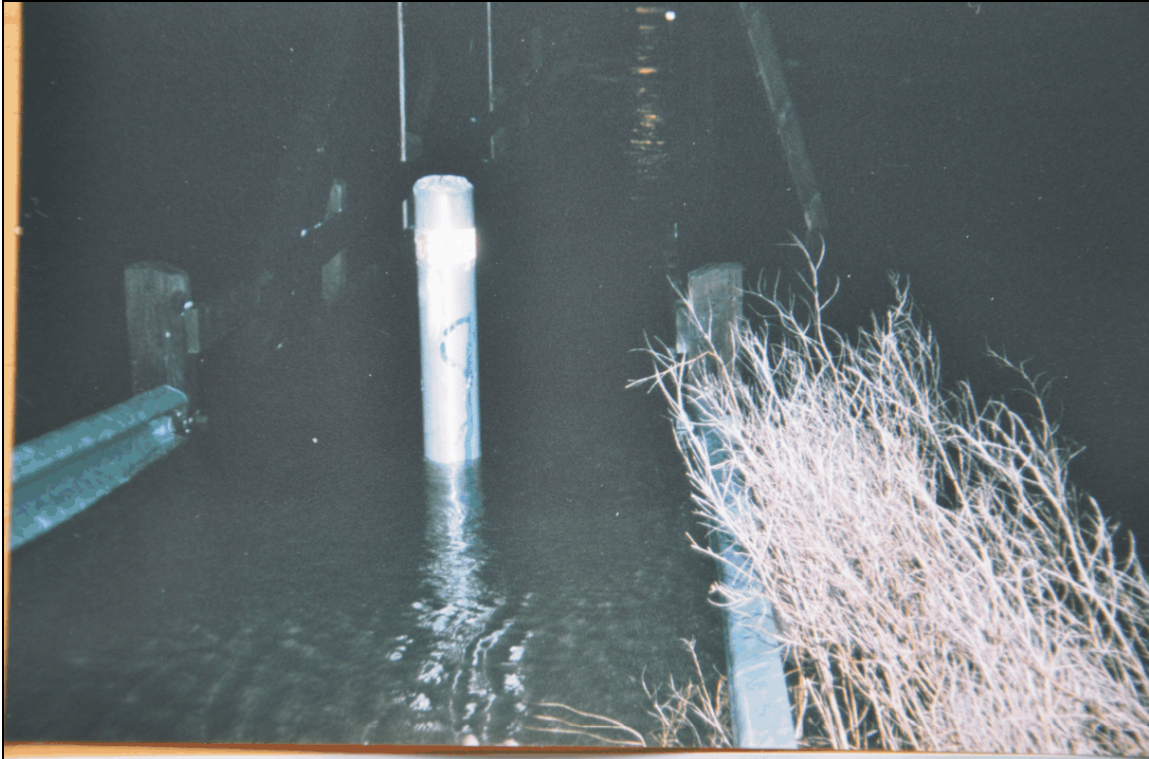
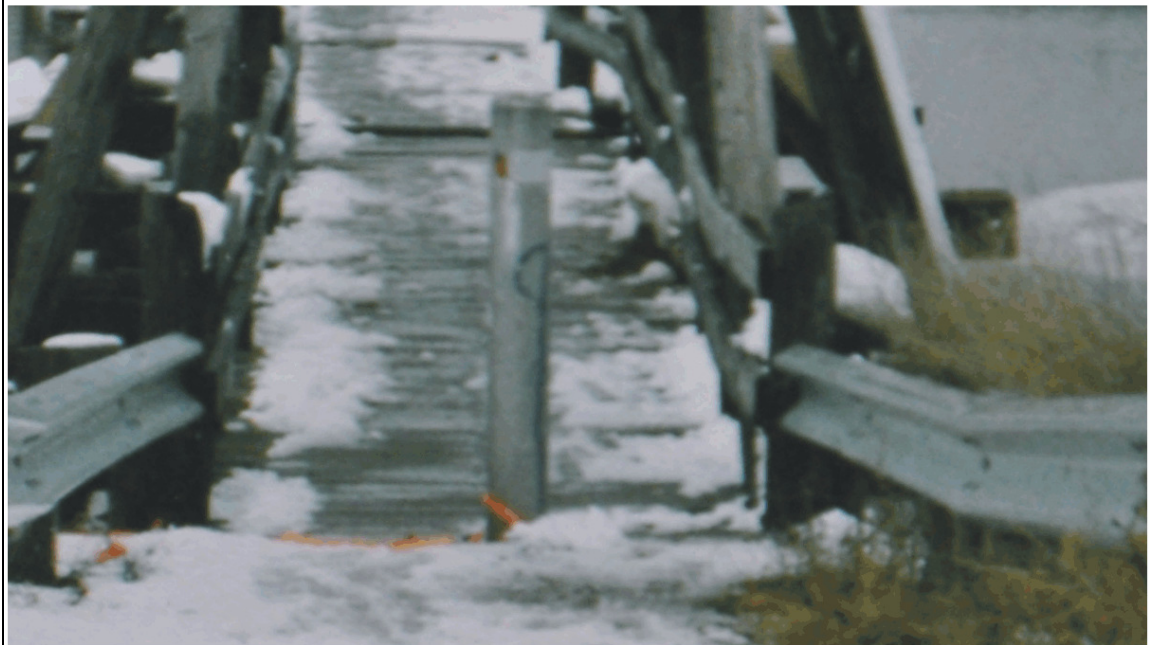
**Figure 7 Foot bridge in Port Elgin covered in water during the storm surge event Jan 2, 2010 (top) and after the storm (bottom).**

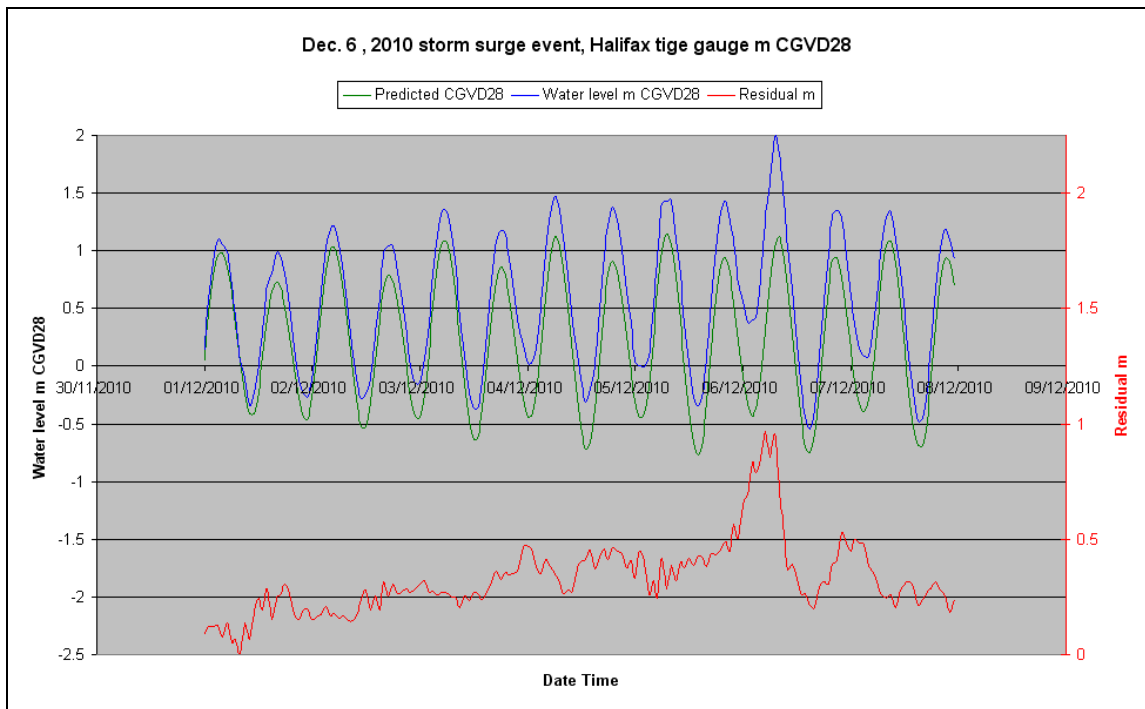
Figure 12 Halifax tide gauge record, hourly readings. The maximum water level is 1.99 m CGVD28 with a storm surge of 0.96 m.

The Halifax tide gauge was operating during the storm event and has been downloaded along with predicted tidal elevations to calculate the residual or storm surge level (Fig. 12). The maximum water level from the hourly tide gauge record at Halifax indicates high-water elevation of 1.99 m (Fig. 12).

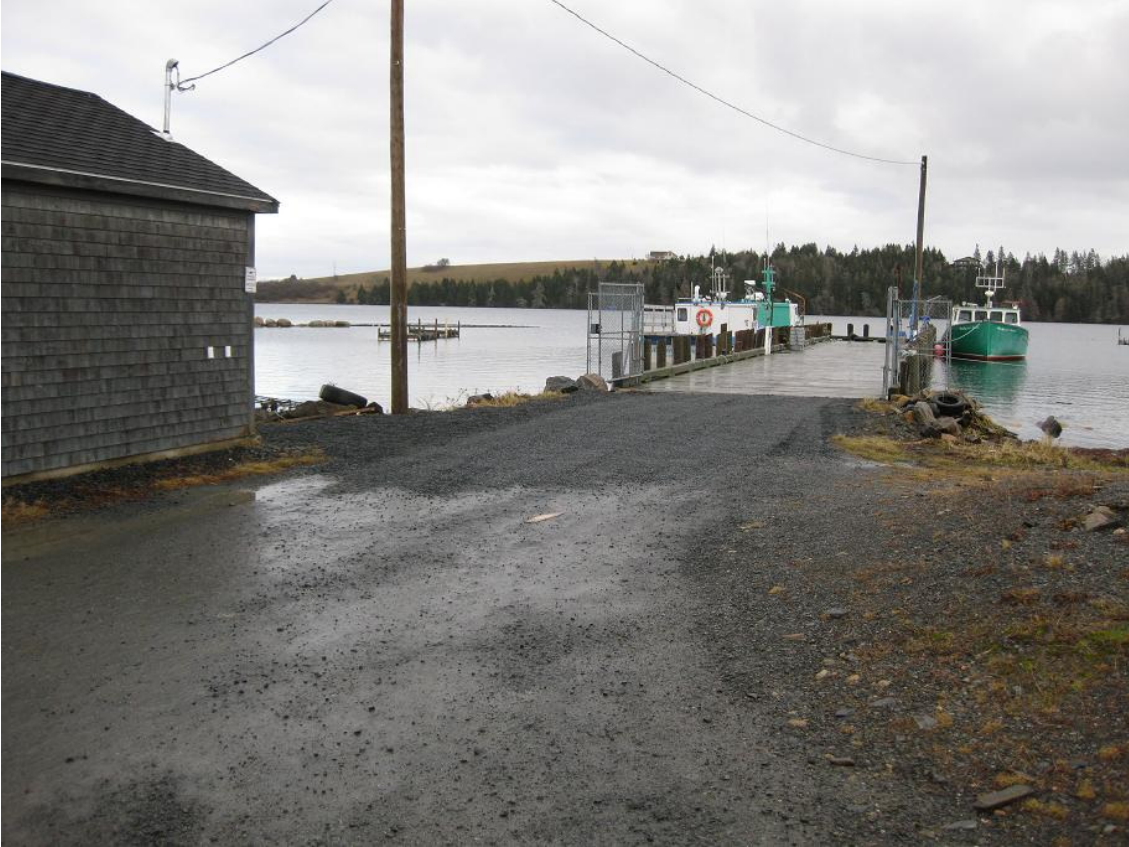
**Figure 16 Bay Port wharf after Dec 6, 2010 storm surge. Nail in power pole marking the high-water elevation.**

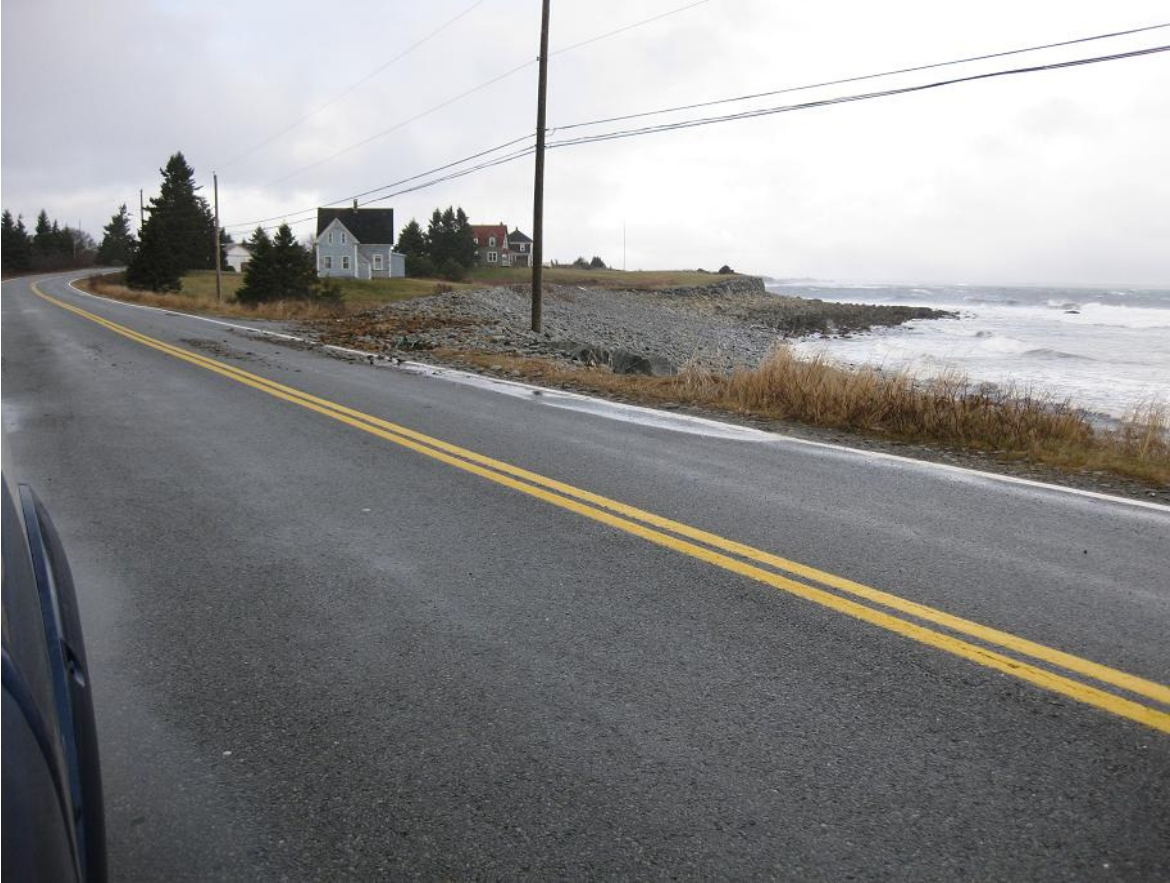
**Figure 17 Broad Cove after Dec 6, 2010 storm surge. Nail in power pole marking the high-water elevation. Note the gravel from the beach deposited on the road.**

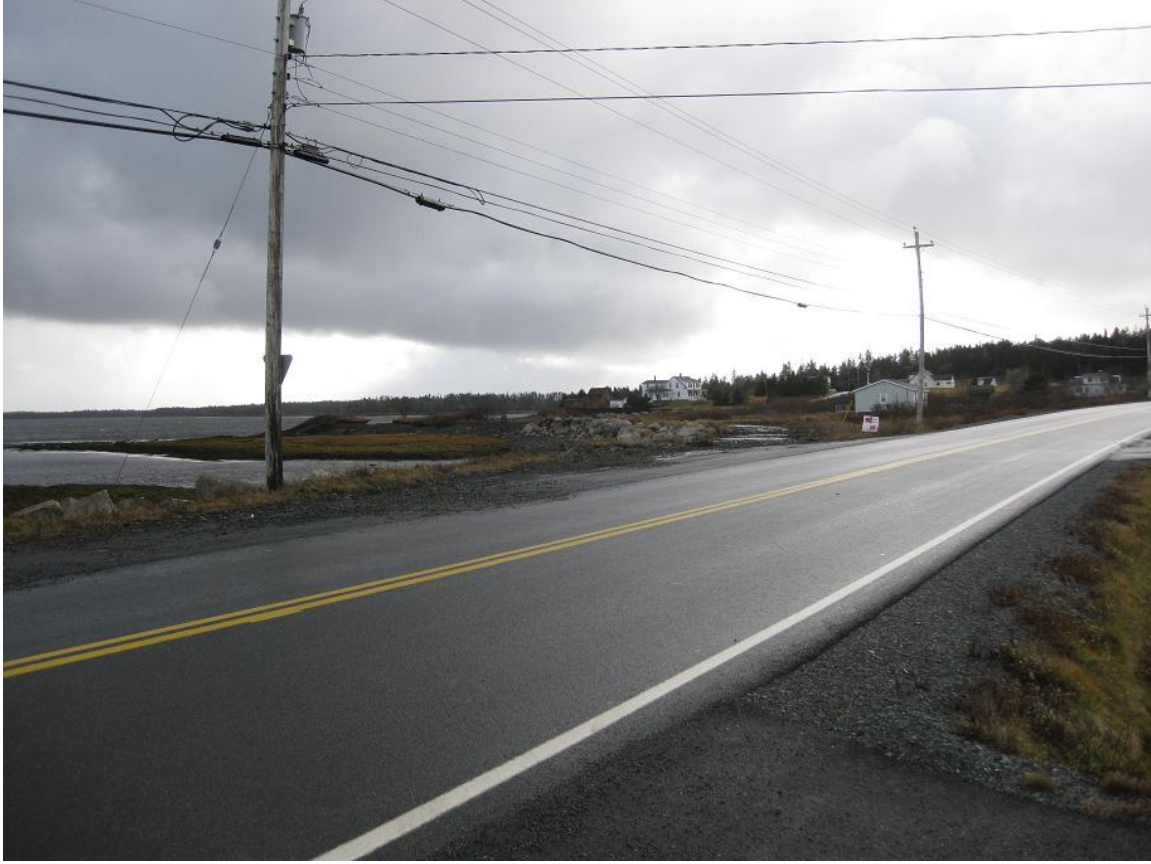
**Figure 18 Dublin shore after Dec 6, 2010 storm surge. Nail in power pole marking the high-water elevation.**

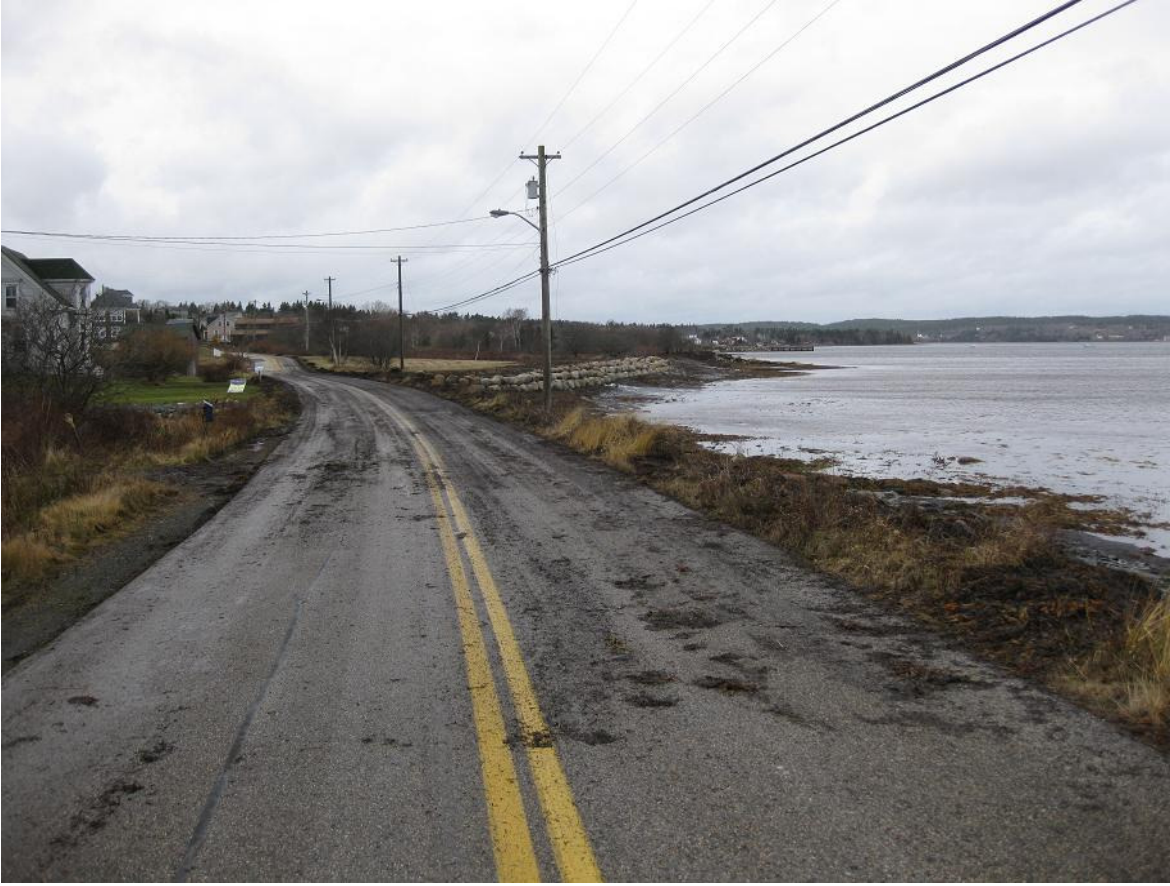
**Figure 19 Kingsburg Road Cove after Dec 6, 2010 storm surge. Nail in power pole marking the high-water elevation. Note the gravel and debris from the beach deposited on the road.**

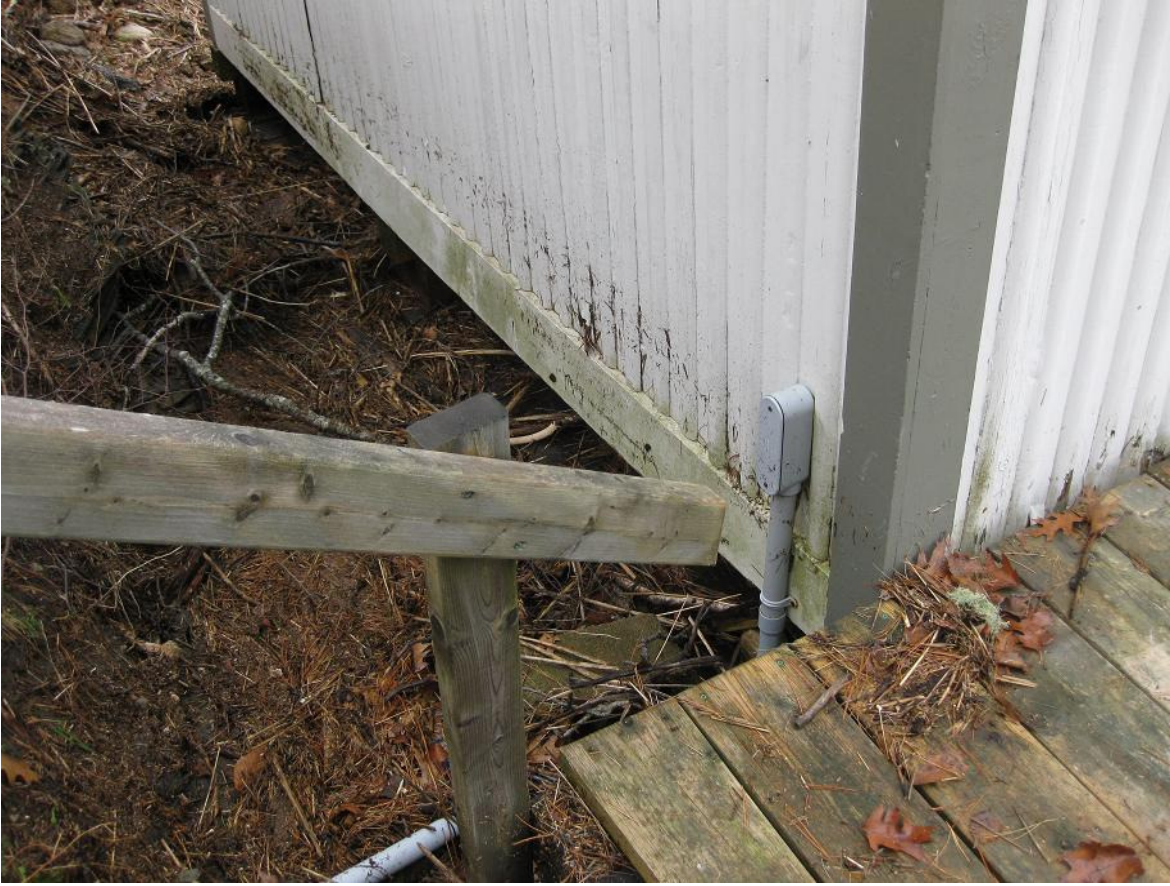
**Figure 20 Upper LaHave “Mills Boat House” after Dec 6, 2010 storm surge. The debris line is marking the high-water elevation.**

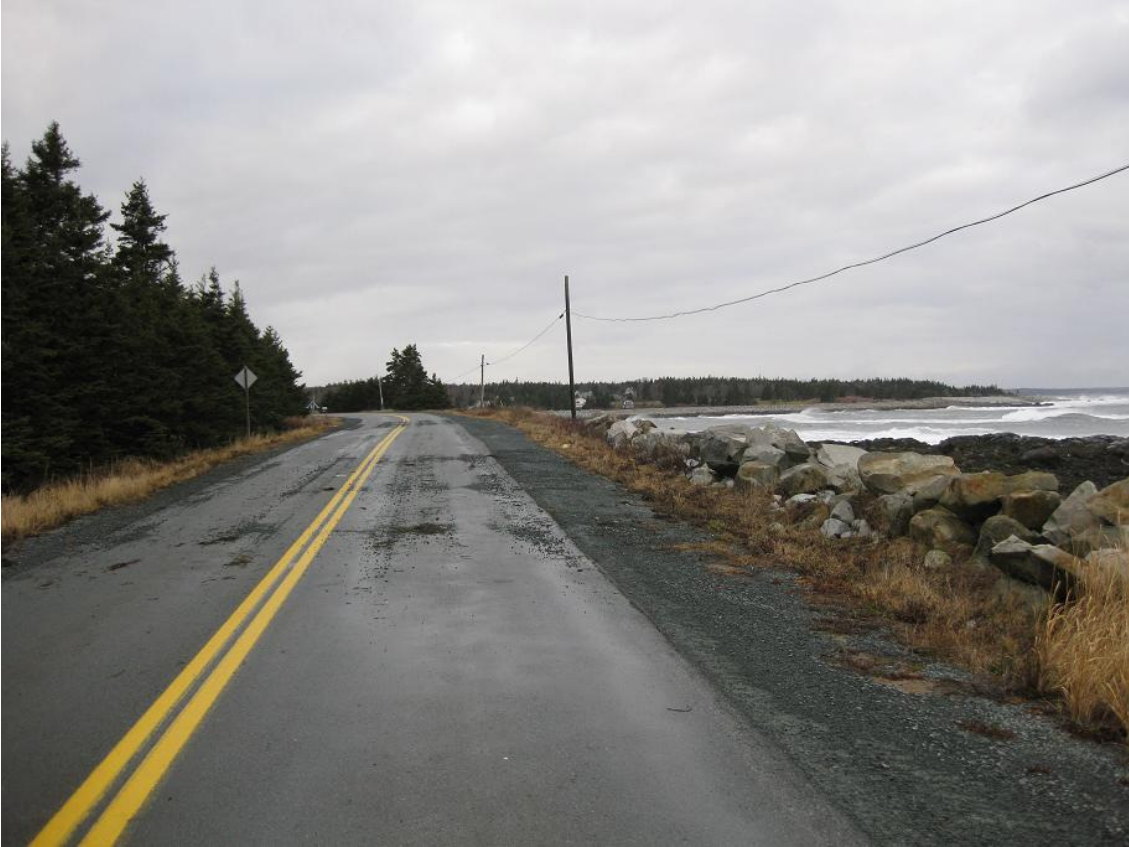
**Figure 21 Western Head after Dec 6, 2010 storm surge. Nail in power pole marking the high-water elevation. Note the gravel from the beach deposited on the road.**

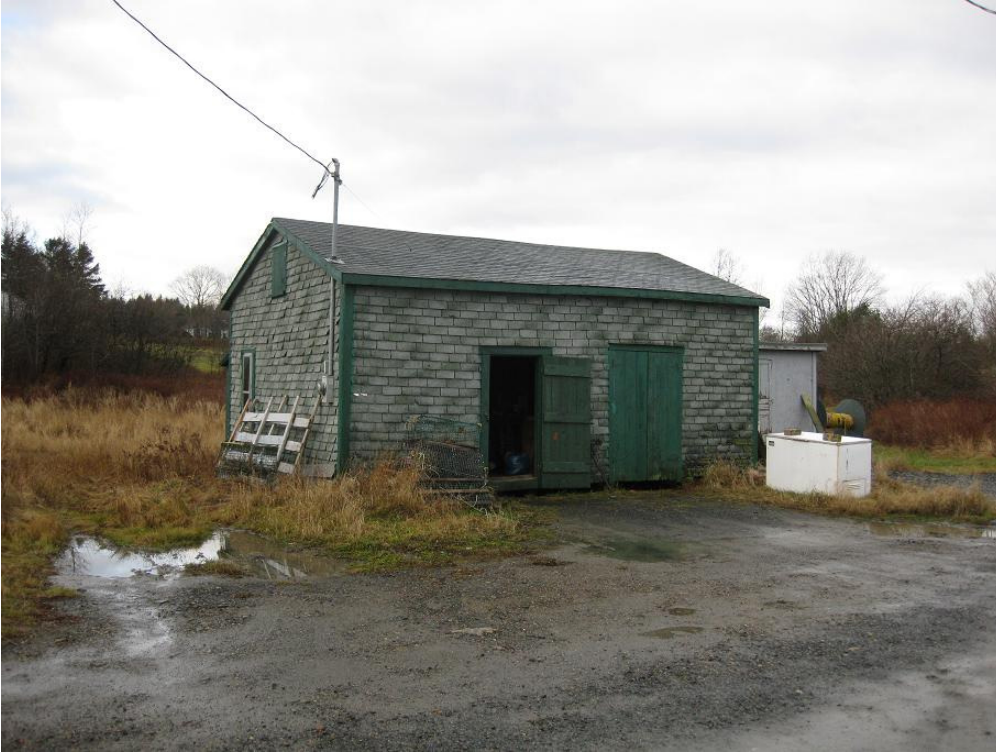
**Figure 22 Bay Port fish shack after Hurricane Juan Sept. 28-29, 2003.**

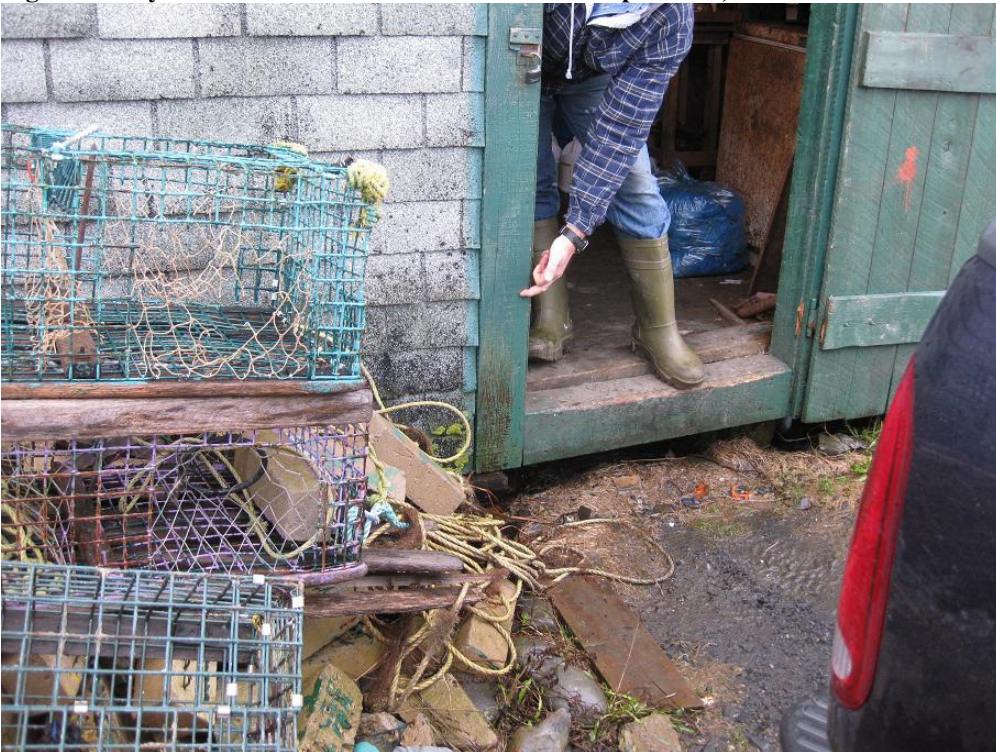
**Figure 23 Witness pointing to high-watermark from Hurricane Juan, Sept 28-29, 2003.**

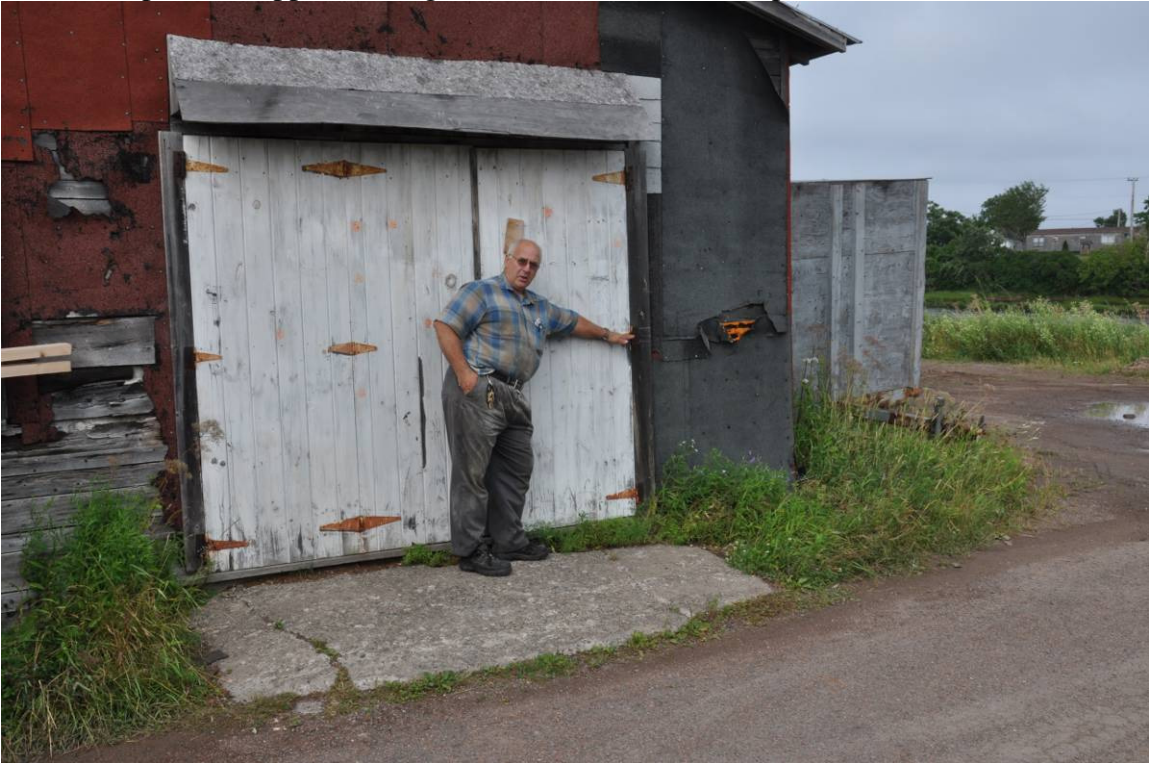
**Figure 26 Port Elgin high-water level from eye witness. RTK GPS orthometric height measured 3.20 m.**

The high-water mark measured by RTK-GPS indicated a level of 3.20 m CGVD28 (Appendix B) in contrast to the level at Shediac (2.14 m CGVD28) and Charlottetown (3.19 m CGVD28).

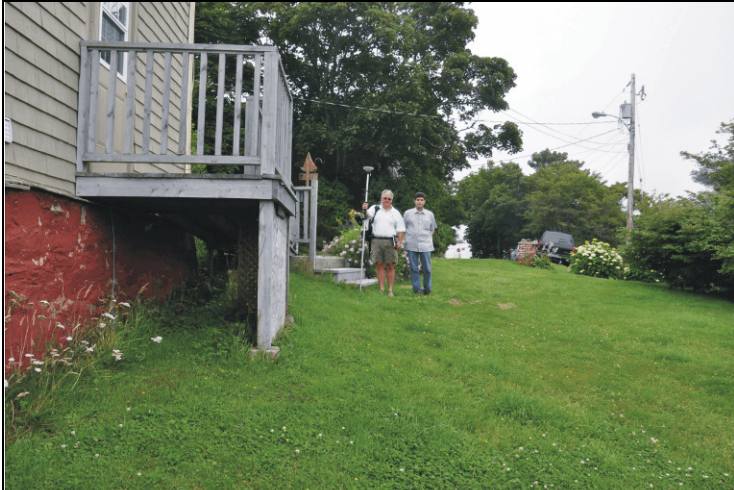
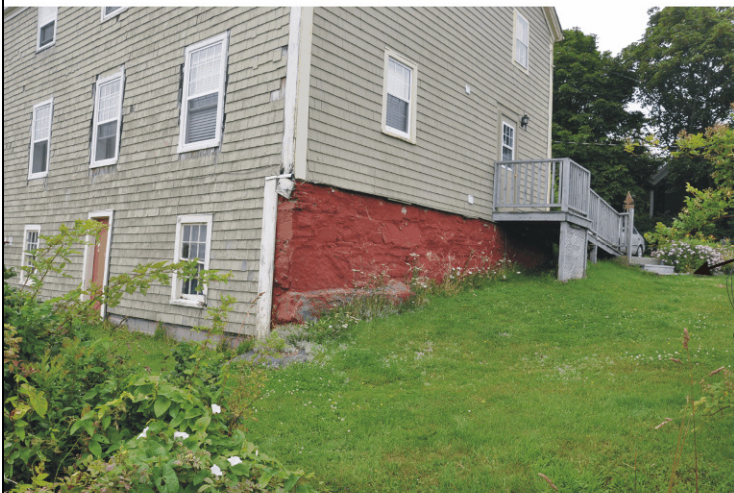
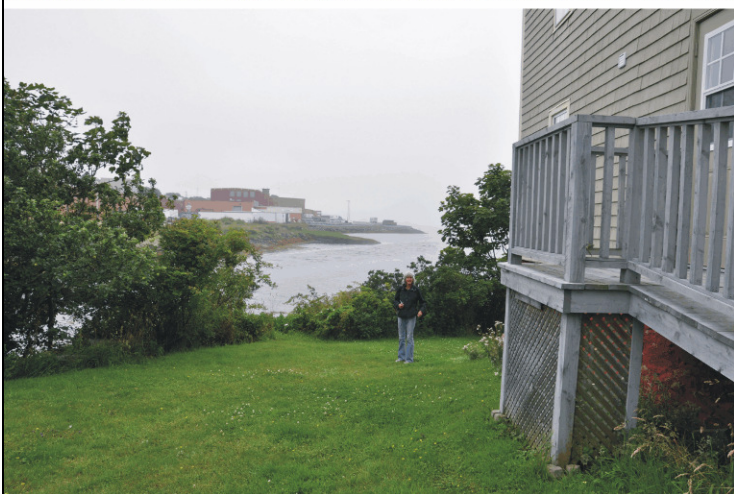
RTK water level

Water level reached the bottom of the door step on Groundhog Day Storm Feb. 1976.

This house is at the head of Yarmouth Harbor

**Figure 28 High-water mark being surveyed in Yarmouth from Feb. 3, 1976 Groundhog Day Storm. 4.81 m CGVD28 elevation from GPS of high-water mark.**

The RTK GPS elevation of the high-water marks; one based on eye witness reports of the water coming to the door step of a house (4.81 m CGVD28), and the other mark was estimated based on historical photographs of water covering a cars tires near the present Printer Works building (3.56 m CGVD28) (Appendix B).

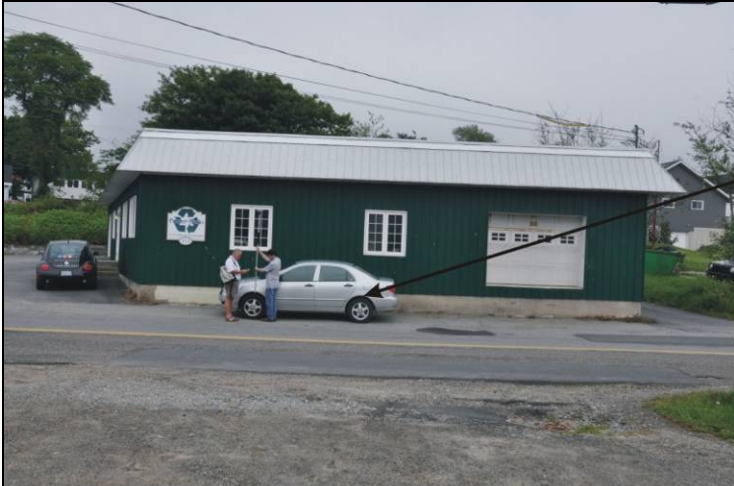
Photo showing this building with water above the tire of a VW bug car. My tires 1 inch lower.

Original Photo showing this building with water above the tire of a VW bug car.

**Figure 29 High-water mark being estimated and surveyed based on historic photo Feb 1976 (courtesy of the Vanguard Newspaper). RTK GPS of the top of the tire 3.56 m CGVD28.**

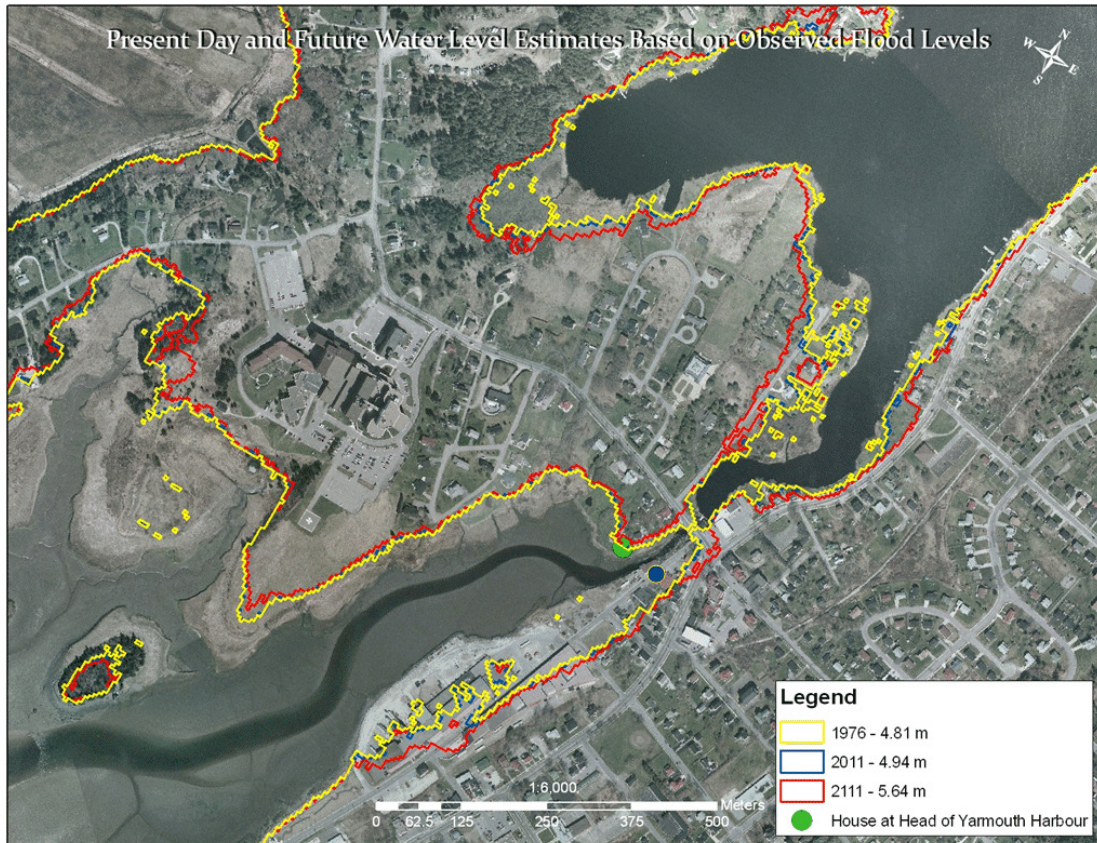
**Figure 30 Yarmouth location map. Green dot is the back door step high-water mark and the blue dot is the top of car tire high-water mark RTK-GPS survey locations. The yellow line is the flood limit of 4.81 m high-water (door step elevation), the other lines represent sea-level rise in the future.**

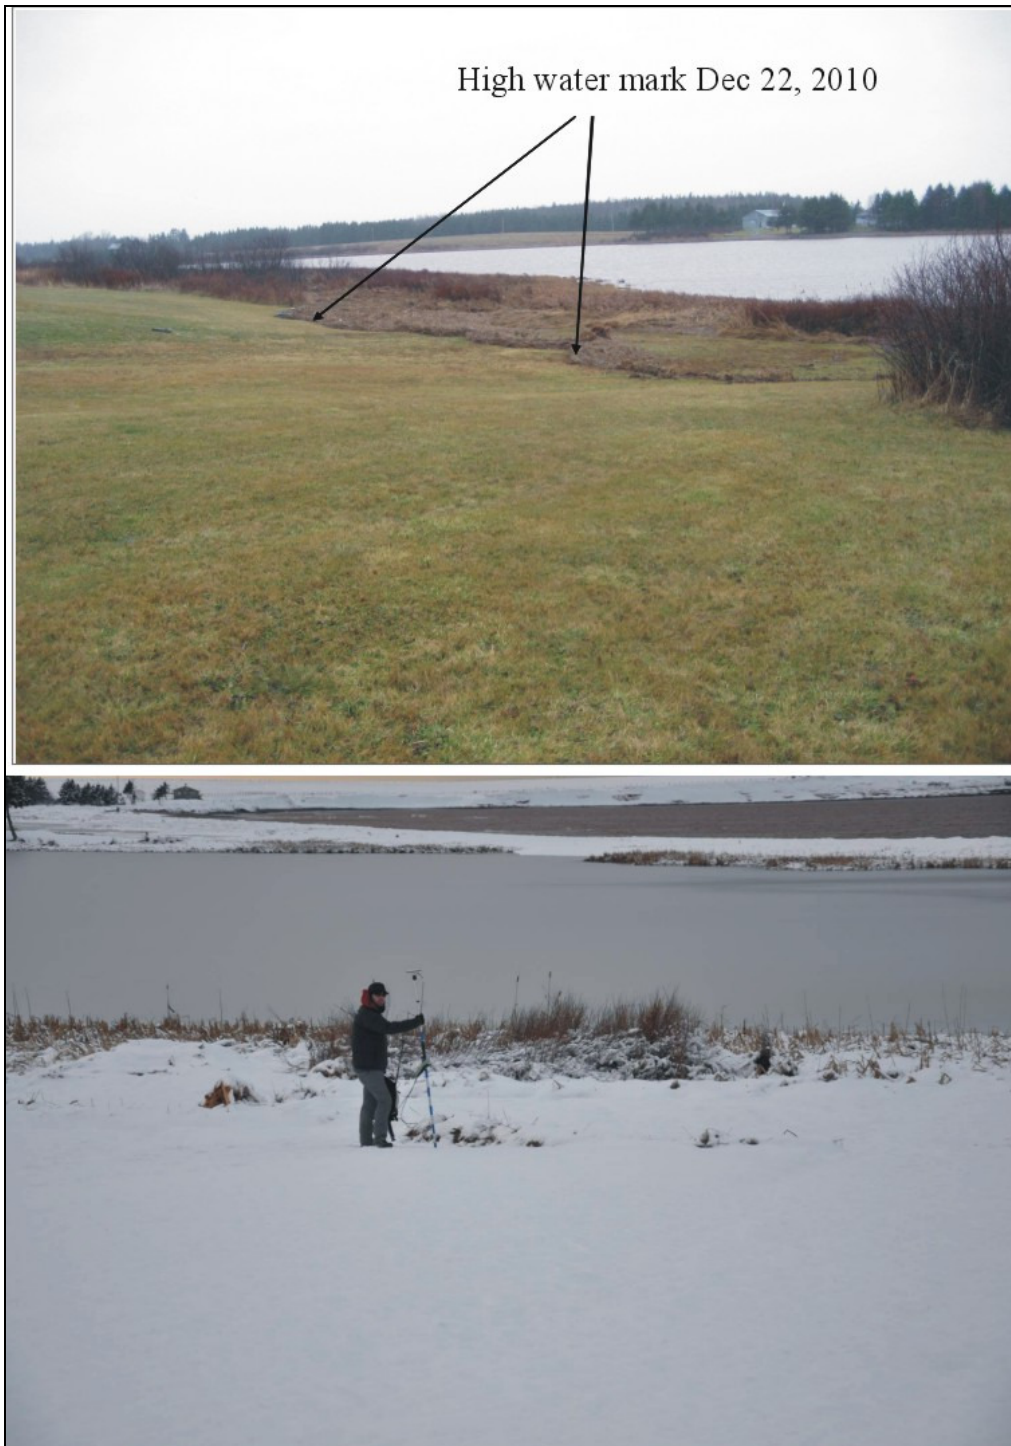
**Figure 31 Debris high-water line from Dec 21-22, 2010 storm at Cape John (top photo). RTK GPS of high-water line indicates a water level of 2.38 m CGVD28.**

**Dec 21-22, 2010** Cape John - wrack line GPS = 2.38 m CGVD28 via GPS
